S-345 Richardson Farm Princess Anne vicinity private c. 1840-1850

## Survey No. €-345

## Maryland Historical Trust State Historic Sites Inventory Form

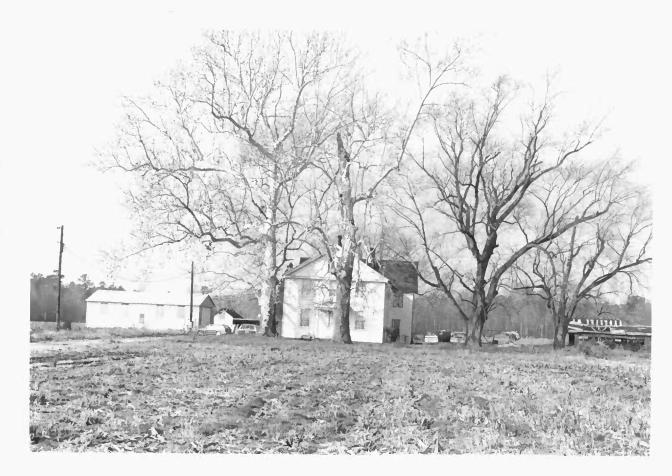
Richardson Farm S-345
Princess Anne vicinity, Somerset Co., MD
Southwest elevation
11/85, Paul Touart, Photographer
Neg., MD Hist. Trust

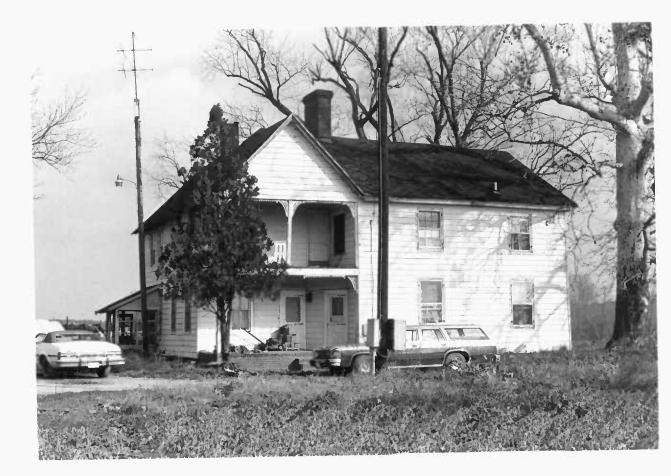
Richardson Farm S-345
Princess Anne vicinity, Somerset Co., MD
Southwest Elevation
11/85, Paul Touart, Photographer
Neg./MD Hist. Trust

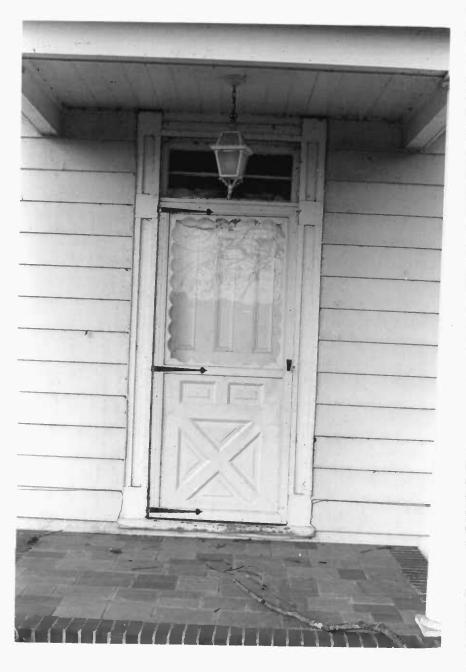
The south (main) elevation is a symmetrical three-bay elevation with a center entrance and flanking six over six sash windows. The paneled front door is framed by a paneled door surround, and the door is topped by a four-light transom. Three six over six sash windows light the second floor. Located within the pedimented gable front is a pair of four over four sash windows. The cornice has mid nineteenth century bed and crown molding.

Richardson Farm S-345
Princess Anne vicinity, Somerset Co., MD
Front door
11/85, Paul Touart, Photographer
Neg./Md Hist. Trust
